## Testing of TAMU1 Dipole

*Abstract.* The NbTi model dipole TAMU1 was successfully tested at Lawrence Berkeley Lab. The dipole reached 84% of short-sample current on the first quench, and trained rapidly to 96%. Notwithstanding a variety of component failures during fabrication and assembly, the dipole still had sufficient provisions for monitoring and quench firing to permit a fairly extensive study of its performance. The quench heaters were capable of inducing quench in <10 msec. The splice resistance was measured to be 0.28 n $\Omega$ , consistent with excellent splice contact. AC loss properties were studied during ramp studies. Ramps to 1,000 A/s were sustained. The dipole is a success.

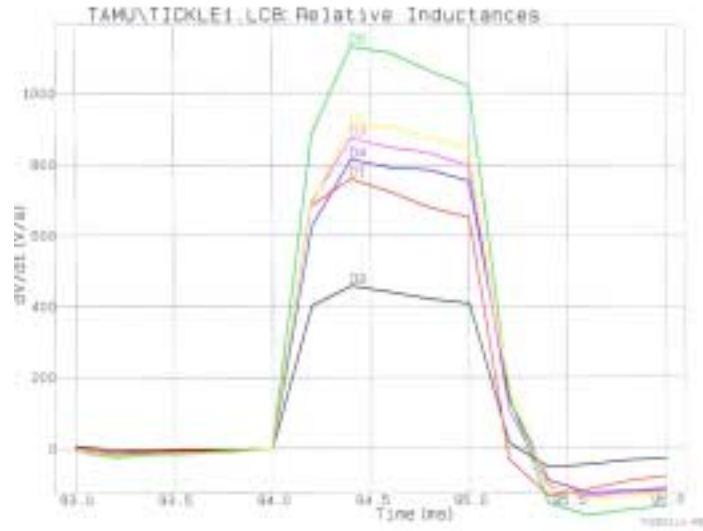
Figure 4. Voltage response to triangular current ramp (20 A max).

The dipole was cooled to 4.5 K, and all windings were checked for turn-to-turn shorts by driving a triangular current waveform through the coil. The rate-of-rise was twice the rate-of-fall, so that the inductance of each winding could be checked independently at two frequencies. Figure 4 shows the voltage response. The voltages across coils 1 and 2 were observed to be mismatched by a ratio ~1.7, much more than the resistive mismatch ratio of 1.22 from the location of the voltage tap, indicating that there was a turn-to-turn short.

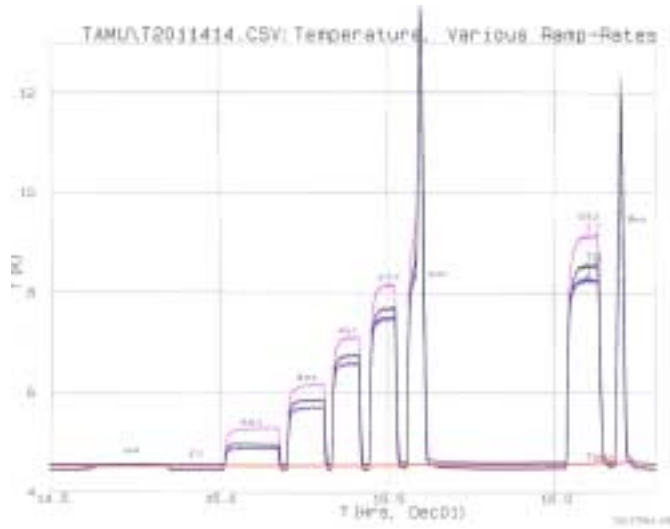
Figure 5. Temperature response in coil during current ramp sequence.

Figure 5 shows the temperatures measured at the locations  $T_1$ ,  $T_7$ , and  $T_8$  indicated in Figure 3. Each succeeding plateau region corresponds to a continuous ramp to 300 A, at a succession of increasing ramp rates: 50 A/s, 100 A/s, 200 A/s, 300 A/s, 400 A/s, 500 A/s, and finally 600 A/s. At 600 A/s, the coil temperature reached the critical temperature  $T_c = 9.3$  K, and the coil quenched. After recovery, the coil *did not quench* during a repeated 600 A/s ramp sequence, but did with a 700 A/s ramp sequence. Something in the coil had changed to produce this change in behavior.

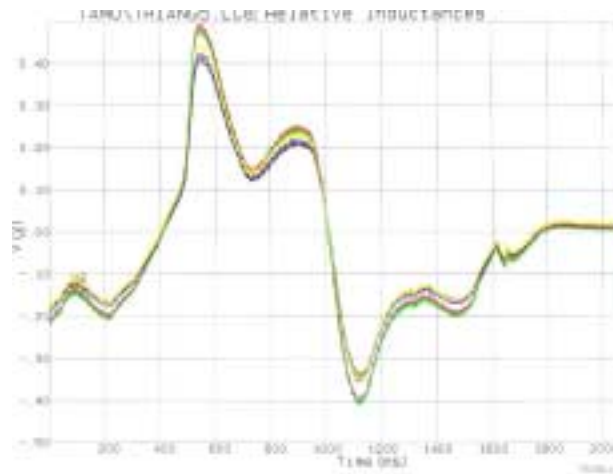
Figure 6. Voltage response to current ramp after ramp processing.

We then measured the voltages across the windings during a ramp to 300 A with 400 A/s up and 200 A/s down. Figure 6 shows the response. All windings exhibited inductances that were consistent with their calculated inductances  $L_i$ , indicating that the short had been successfully removed.

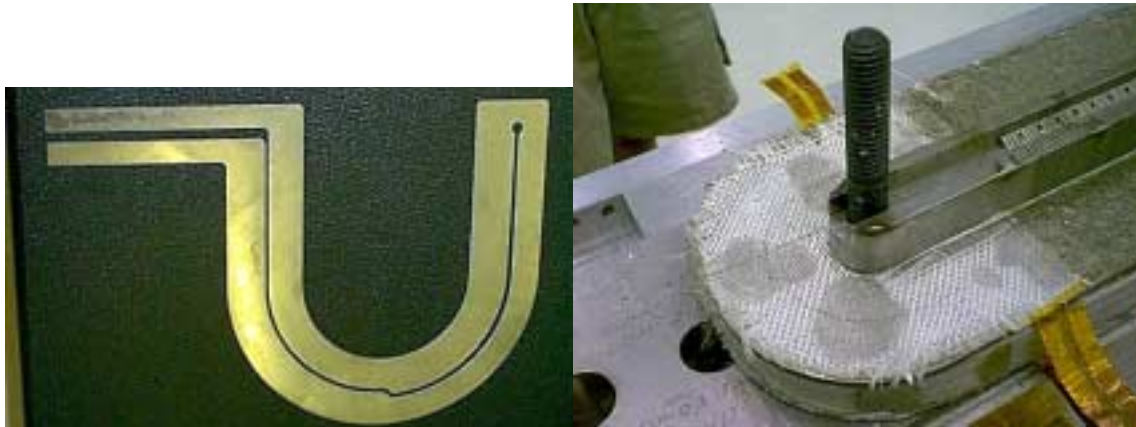
**Figure 7. Quench heater: a) foil heater; b) heater installed with S-glass insulation to coil and mica paper insulation to rib.**

We next increased coil current to 2,000 A, and fired current pulses to the three quench heaters  $Q_i$ , in order to evaluate their effectiveness in initiating quench in the coils that they contacted. Each heater has a room-temperature resistance of  $\sim 1.5 \Omega$ , and is situated to face the edge surfaces of all turns of a winding in the end region, as shown in Figure 7. Although two heaters were installed on each of the six windings, only three were operational by the time of testing. Fortunately the three operational heaters were on windings 2, 4, and 5, so that we were able to fire quench in at least one coil of each double-winding.

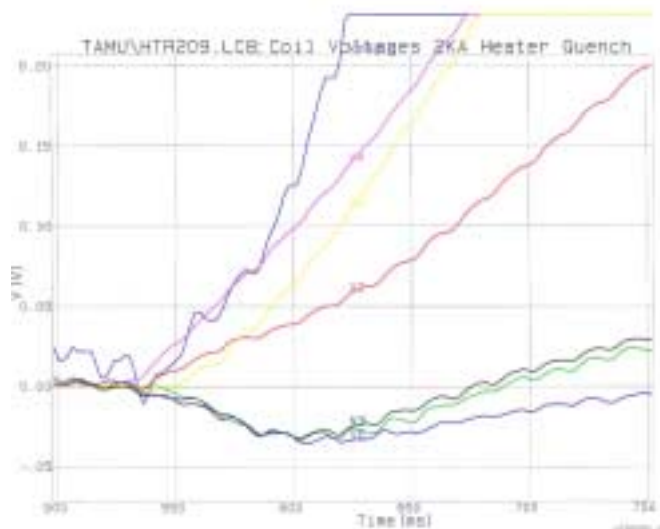
**Figure 8. Voltage response following firing of quench heaters (2,000 A coil current).**

At 2,000 A coil current we fired all three heaters, each with a current pulse of  $\sim 50$  A for  $\sim 30$  ms, corresponding to an adiabatic temperature of  $\sim 200$  K. The voltage response across each coil is shown in Figure 8. On the voltage plot, a positive voltage corresponds to a resistive voltage, while a negative voltage corresponds to an inductive response as the coil current decreases. The three windings with heaters were successfully quenched, while the other three windings remained unquenched for  $\sim 100$  ms and then quenched. We thus validated that the quench heaters worked successfully.

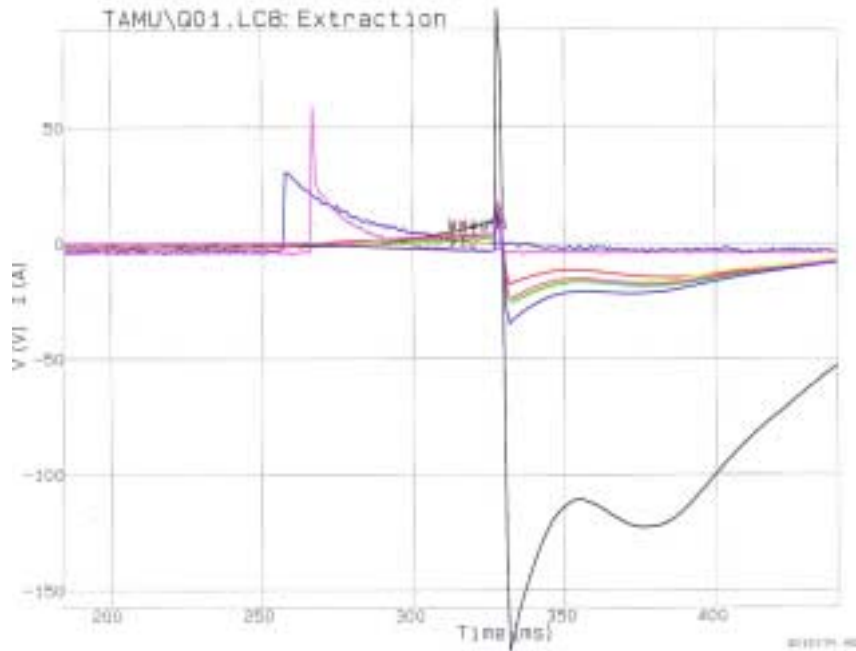
Figure 9. Timing of quench heater firings and energy extraction following detection of a quench.

Figure 9 shows the timing of the quench heater firings and energy extraction after detection of a quench. The delays were introduced to enable us to identify which coil quenched and to observe the initial development of quench in that and other coils.  $Q_4$  was fired  $\sim 10$  ms later than  $Q_2$  and  $Q_5$ , as indicated in Figure 9

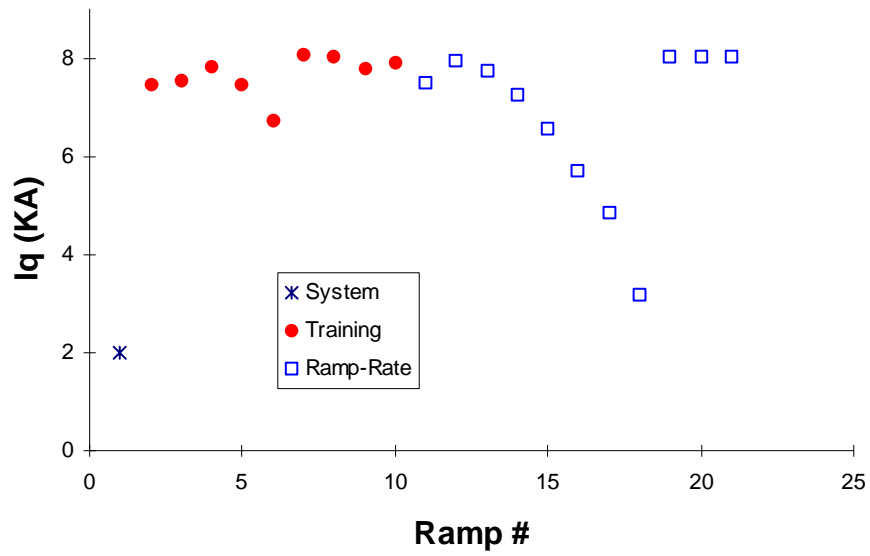
Figure 10. Training history of TAMU1.

We then increased the coil current to measure the maximum field that could be achieved. The current was ramped at 10 A/s. The first quench occurred at a current of 7,200 A, 84% of short-sample current  $j_c = 8,550$  A. Figure 10 shows the training history during a sequence of 9 quenches. The dipole attained a reproducible quench current of  $\sim 8,020$  A, 94% of short-sample.

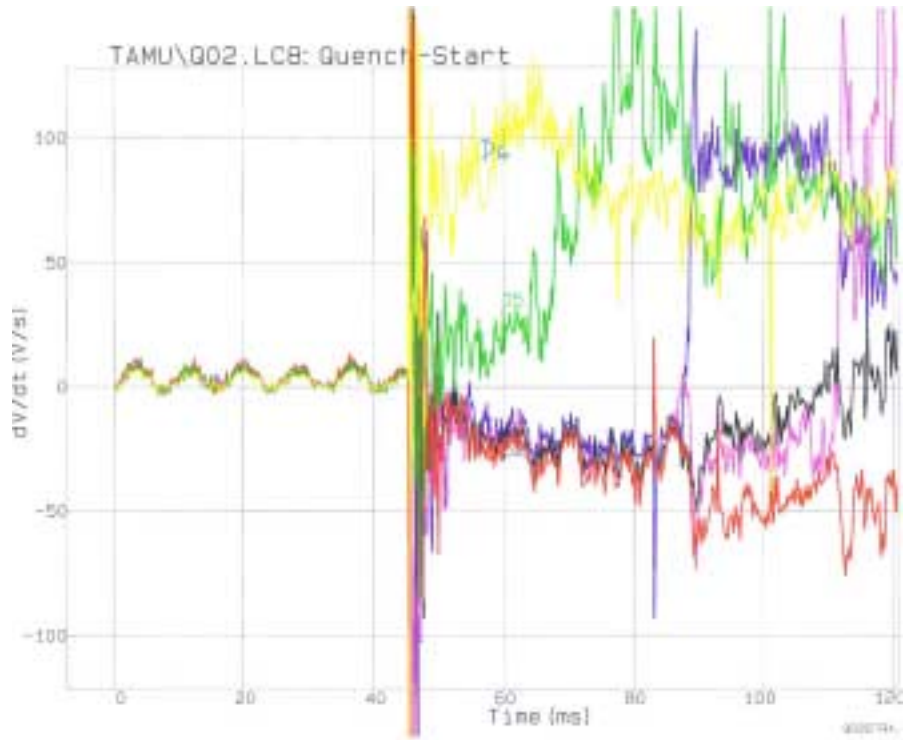
Figure 11. Voltage response during quench, for three quenches: a) quench 2 @ 7,650 A; b) quench 6 @ 8,050 A; quench 8 @ 8,020 A.

Some of the features of the quench behavior of the TAMU1 dipole are illustrated in Figure 11. Quench 2 appears to have been initiated by a major mechanical motion (the huge spike in all traces). Windings 5 and 6 quenched simultaneously. The other windings remained superconducting until the quench heaters were fired.
